**DEPARTMENT OF TRANSPORTATION**

Contract #: 04-0120F4Cty: SF/ALA Rte: 80 PM: 13.2/13.9File #: 1.28**WELDING INSPECTION REPORT****Resident Engineer:** Casey, William**Address:** 333 Burma Road**City:** Oakland, CA 94607**Report No:** WIR-029924**Date Inspected:** 19-Aug-2013**Project Name:** SAS Superstructure**OSM Arrival Time:** 700**Prime Contractor:** American Bridge/Fluor Enterprises, a JV**OSM Departure Time:** 1730**Contractor:** American Bridge/Fluor Enterprises, a JV**Location:** Job Site**CWI Name:** Bernie Docena, Jesse Cayabyab**CWI Present:** Yes No**Inspected CWI report:** Yes No N/A**Rod Oven in Use:** Yes No N/A**Electrode to specification:** Yes No N/A**Weld Procedures Followed:** Yes No N/A**Qualified Welders:** Yes No N/A**Verified Joint Fit-up:** Yes No N/A**Approved Drawings:** Yes No N/A**Approved WPS:** Yes No N/A**Delayed / Cancelled:** Yes No N/A**Bridge No:** 34-0006**Component:** SAS Tower**Summary of Items Observed:**

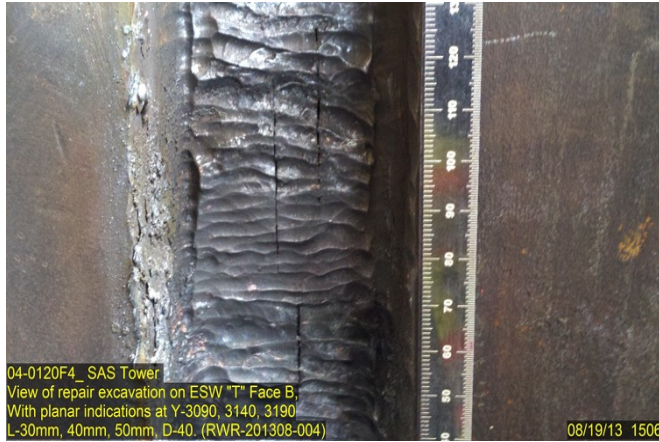
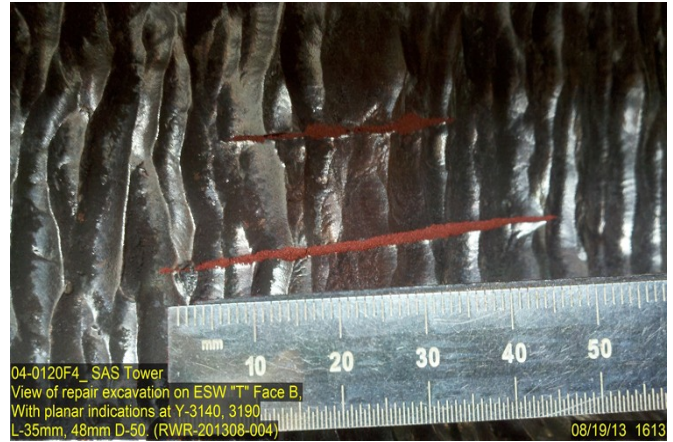
The QA Inspector was later present to observe ABF welder Mike Jimenez (WID-4671) performing excavation of ESW "T" Face B @ Y's-3090mm,3110,3125,3170,3190 to verify indications observed during Ultrasonic Testing pulse/echo & pitch/catch. Mr. Jimenez was performing the excavation using an air carbon arc gouging and a grinder and was instructed by ABF QC Inspector Jesse Cayabyab requested that the welder notify him when indications are visible to allow QC/QA to inspect the excavation. Location of the repair is as follows:

Weld excavated at 40mm dp- 30mm, 40mm, 50mm long planar indications (centerline crack) observed @3090, 3140, 3190.

Weld excavated at 50mm dp- 35mm,48mm long planar indications (centerline crack) observed @ 3140,3190.

Excavation Y=3000mm~3340mm, Current depth-50mm.

The QA Inspector observed the QC Inspector perform an informational MT inspection of the unground excavation and observed that the planar indications remained at the above mentioned depths. The QA Inspector also performed MT verification of the indications. Mr. Cayabyab stated that the excavation work will continue on 8/20/13. The information regarding the planar indications was passed along to ABF and CT METS representatives for additional review. The QA Inspector also informed Tower SMR Aaron Prchlik of the indications observed. See TL-6028 for additional details on items inspected on this date. See TL-6028 for additional details on items inspected on this date.
